Technical Report HL-94-1  
May 1995

# **Demonstration Erosion Control Project Monitoring Program**

## **Fiscal Year 1993 Report**

### **Volume I: Main Text**

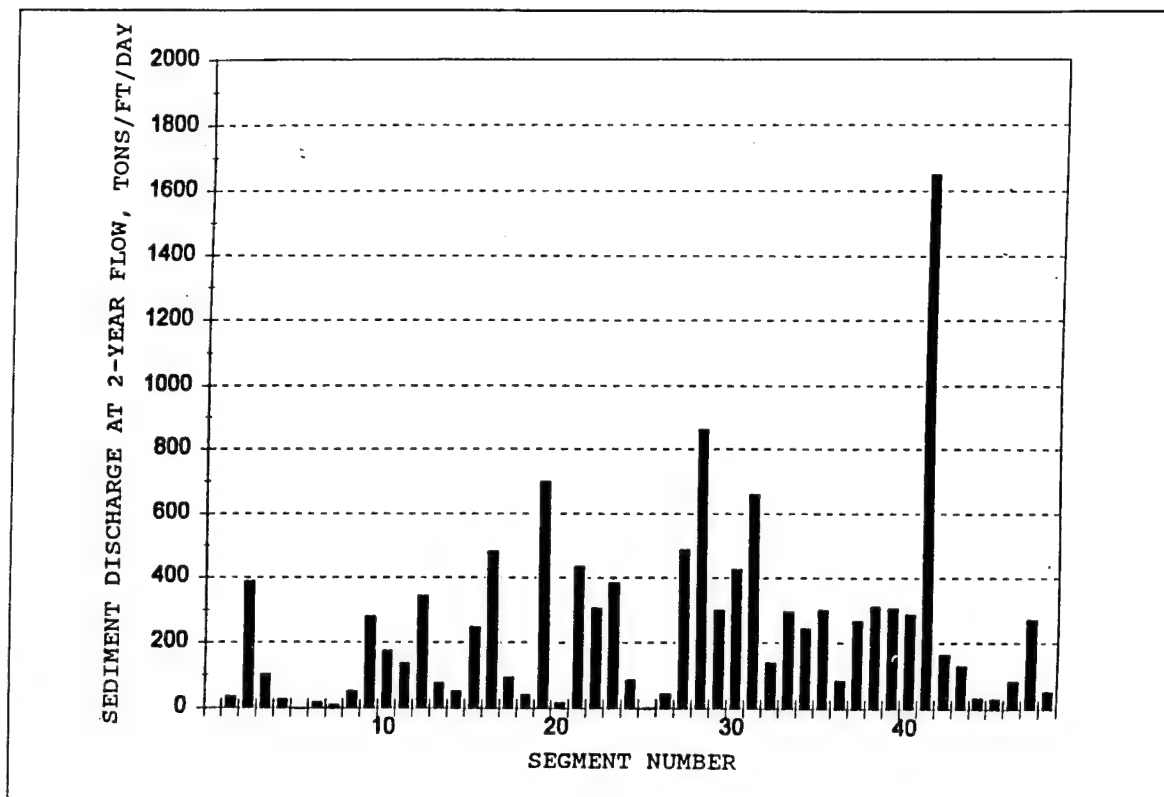
Figure 114. Segment sediment discharge

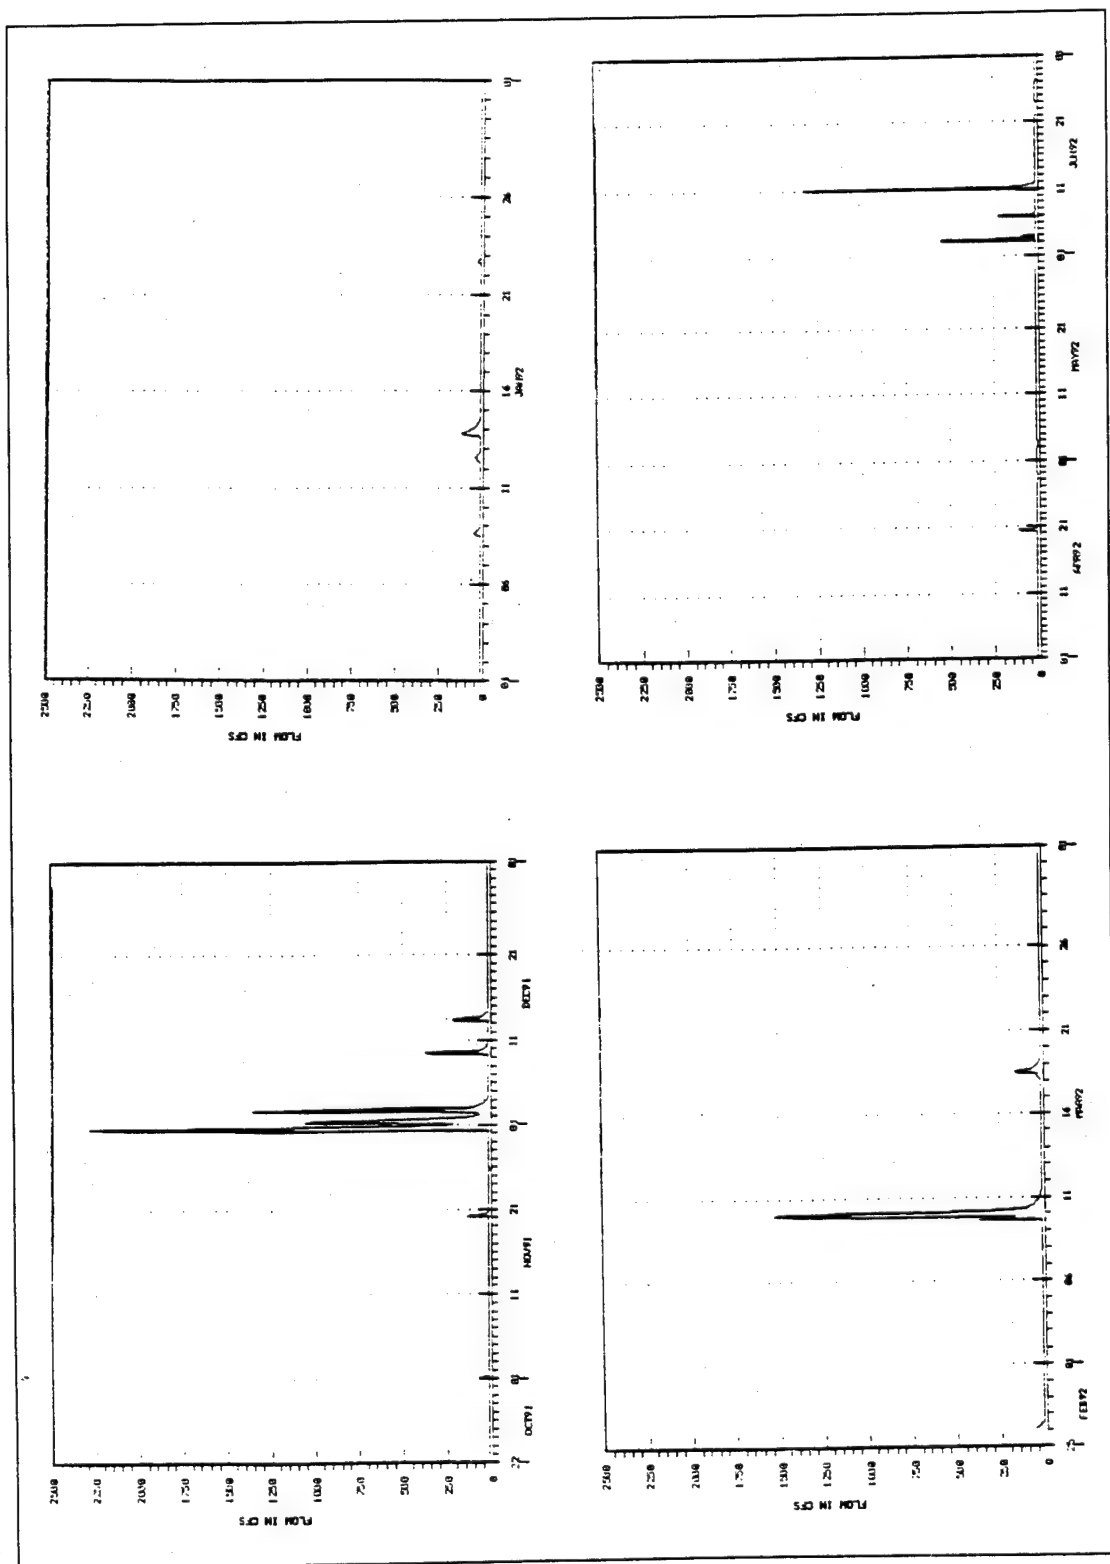
Figure 117. Discharge hydrograph, Long Creek (October 1991-June 1992)

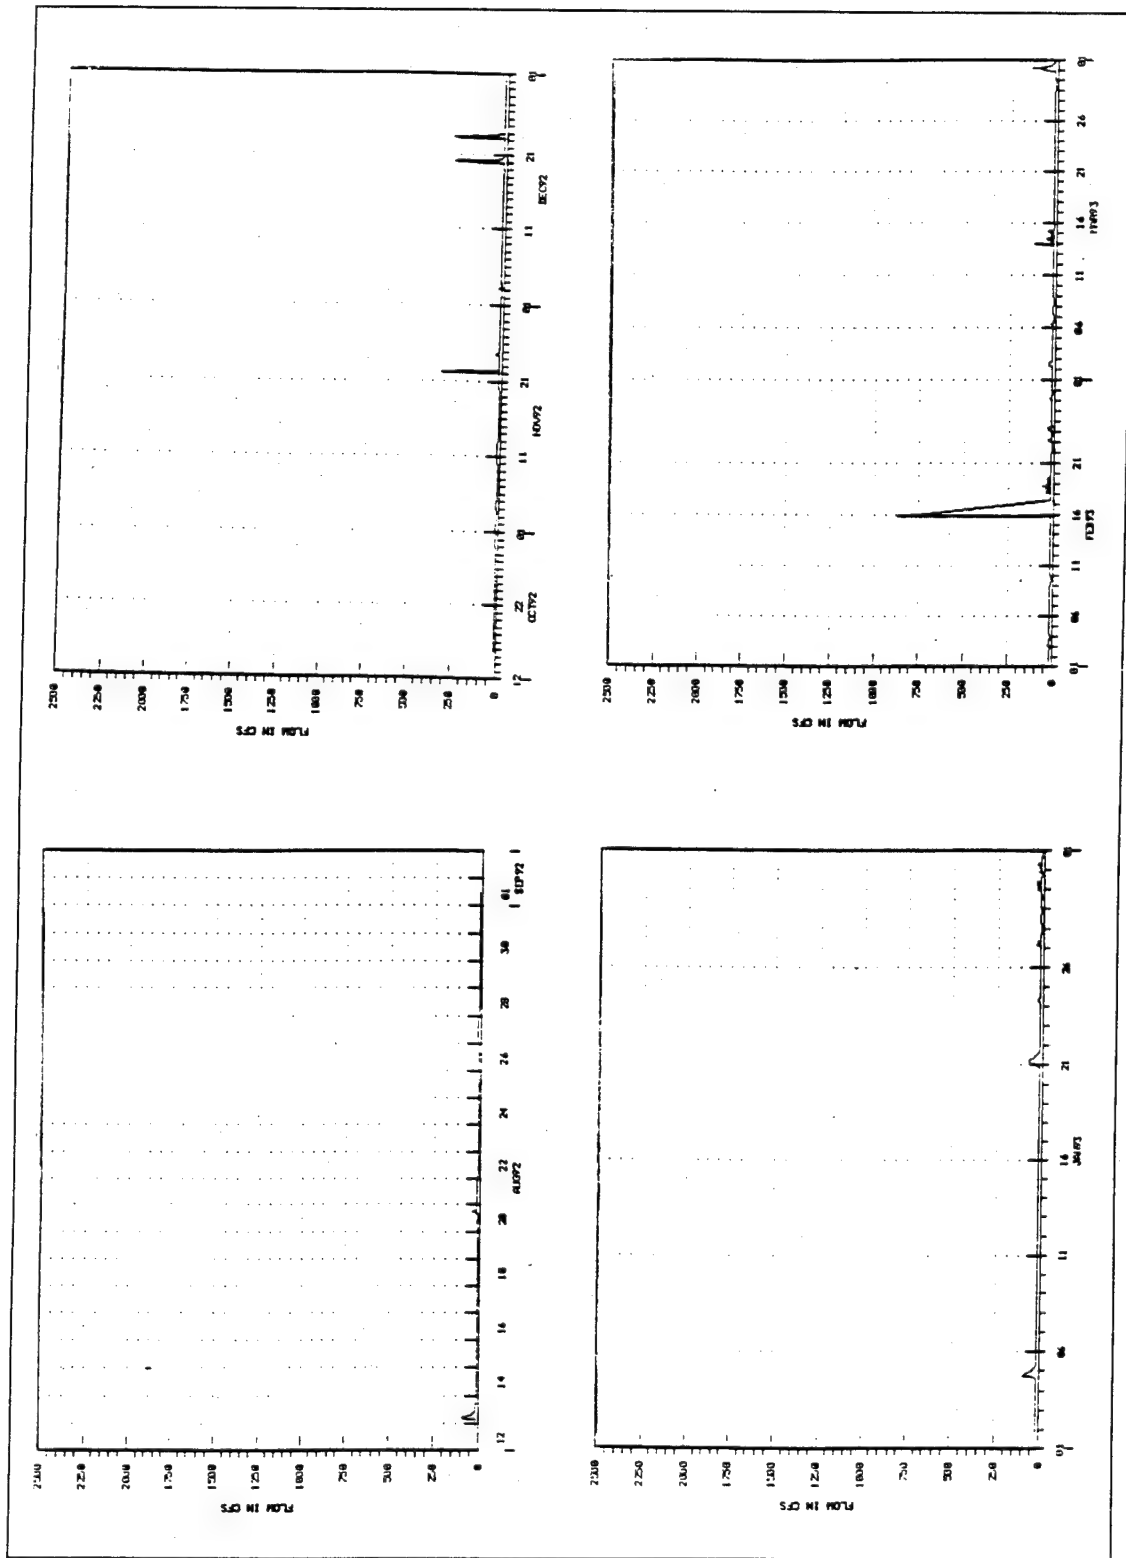
Figure 118. Discharge hydrograph, Long Creek (August 1992-March 1993)

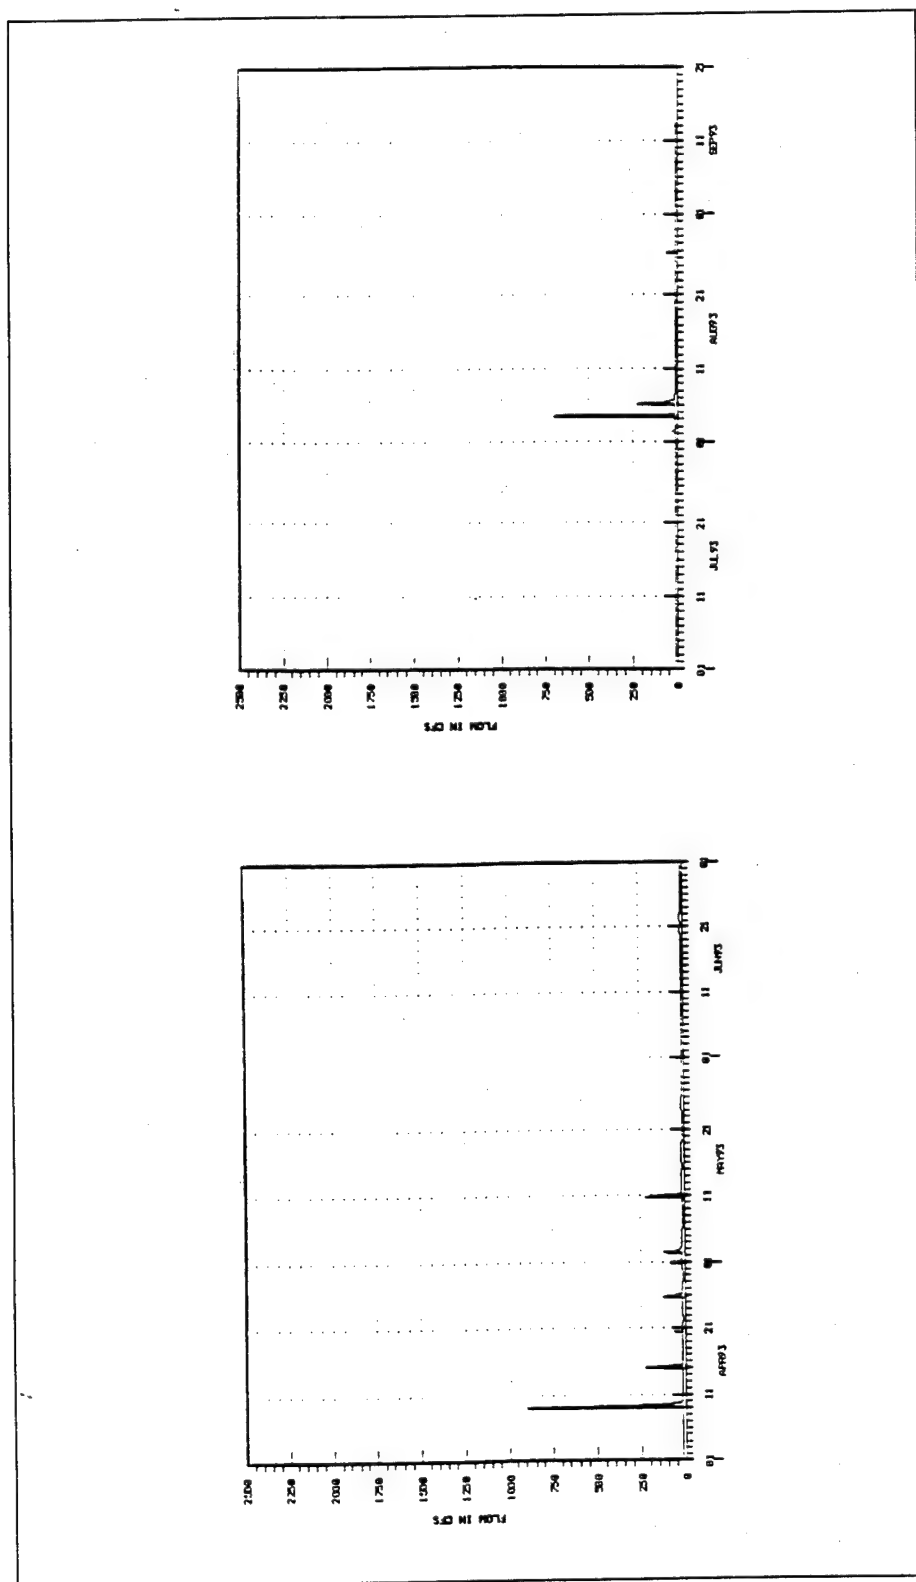
Figure 119. Discharge hydrograph, Long Creek (April 1993-September 1993)

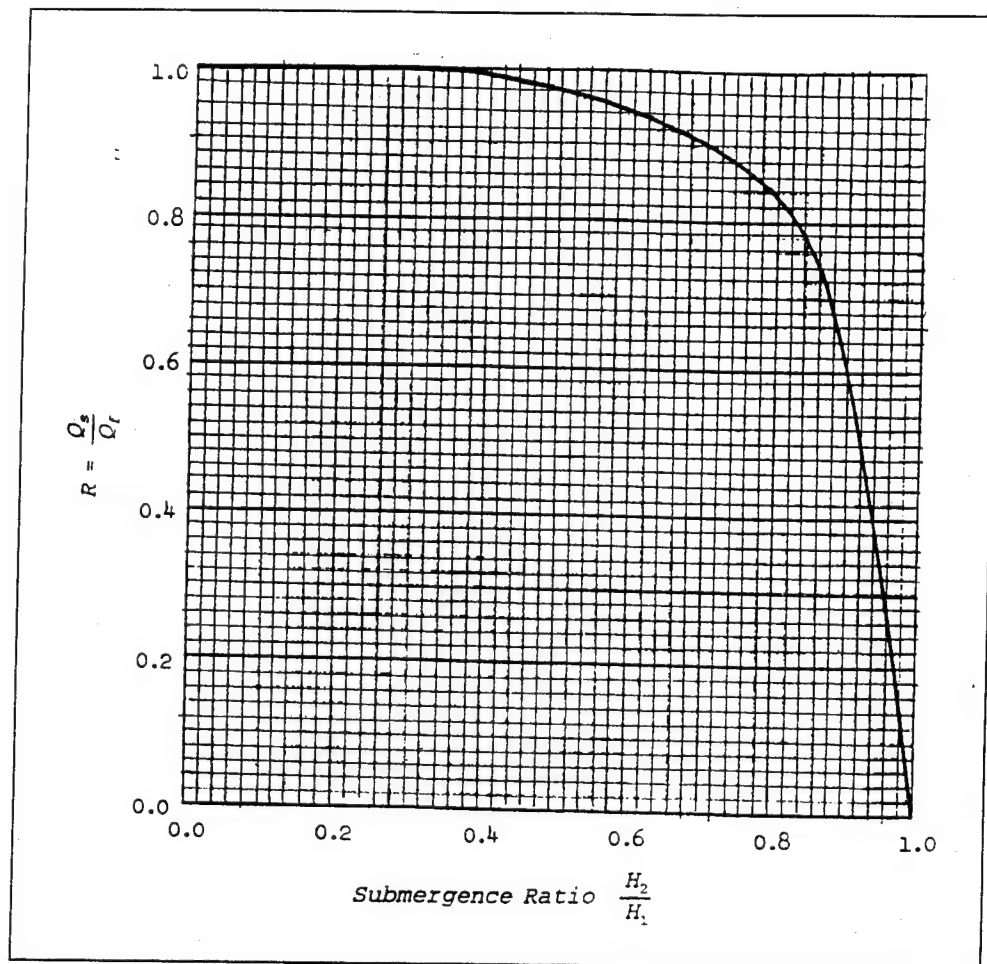
Figure 120. Hotophia Creek high-drop, effects of submergence

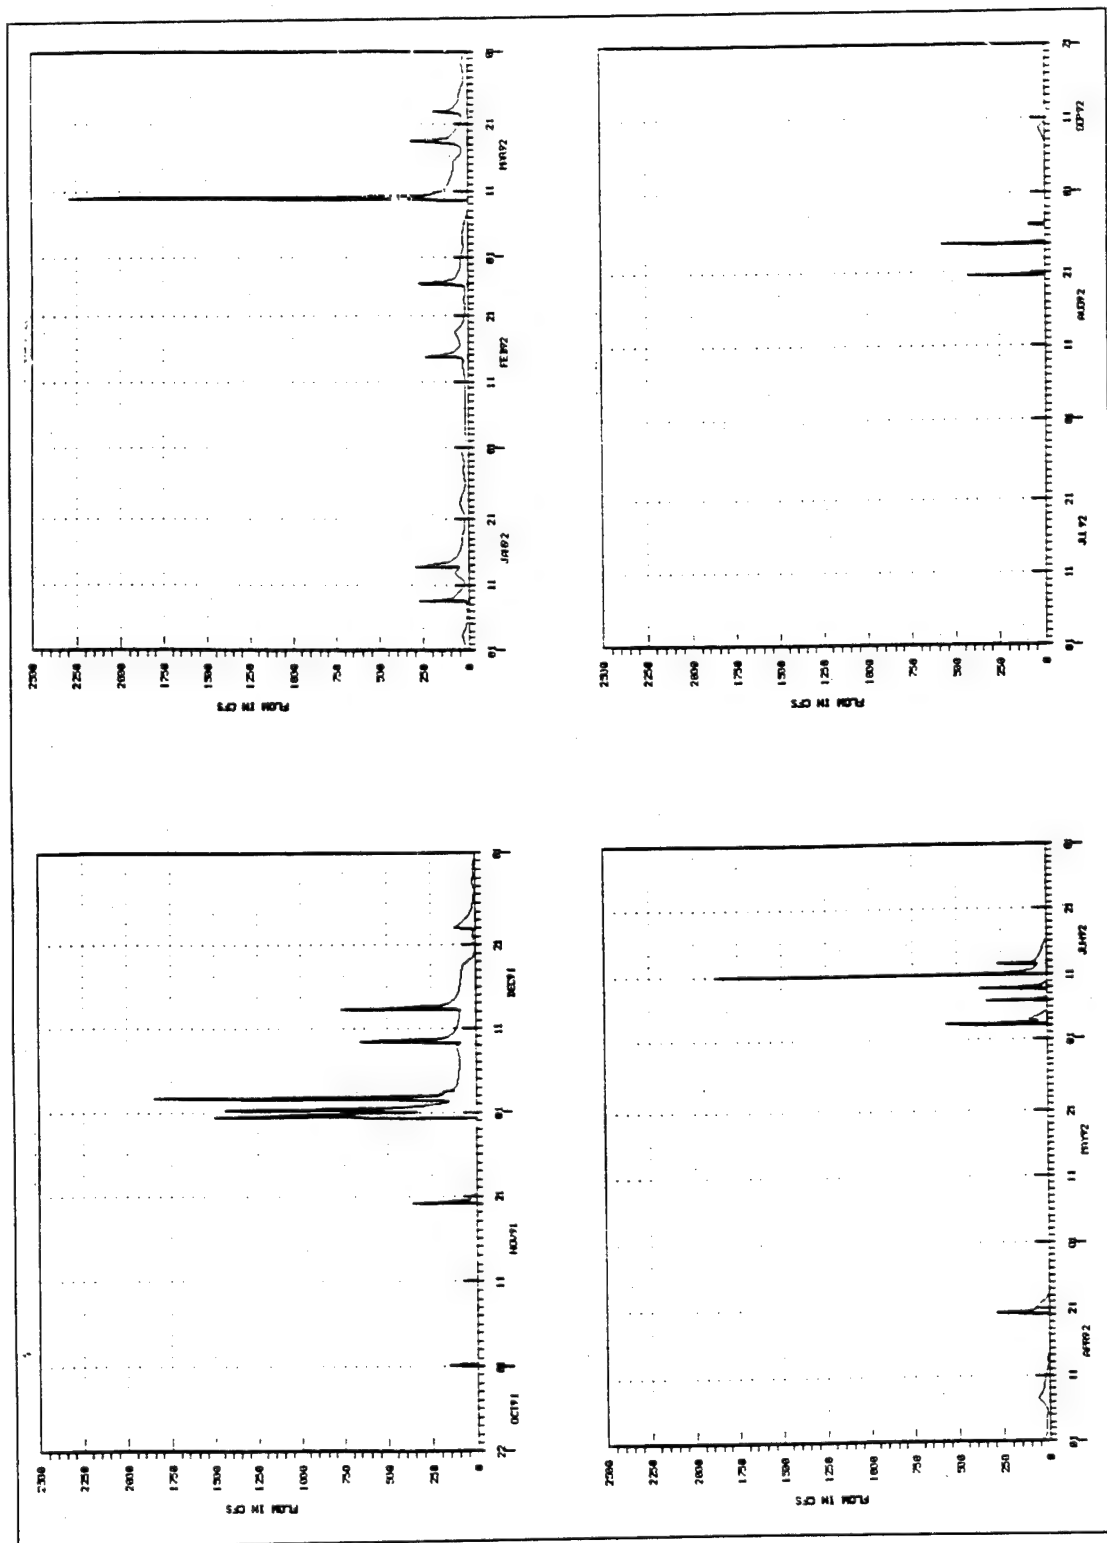
Figure 121. Discharge hydrographs, Hotophia Creek (October 1991-September 1992)

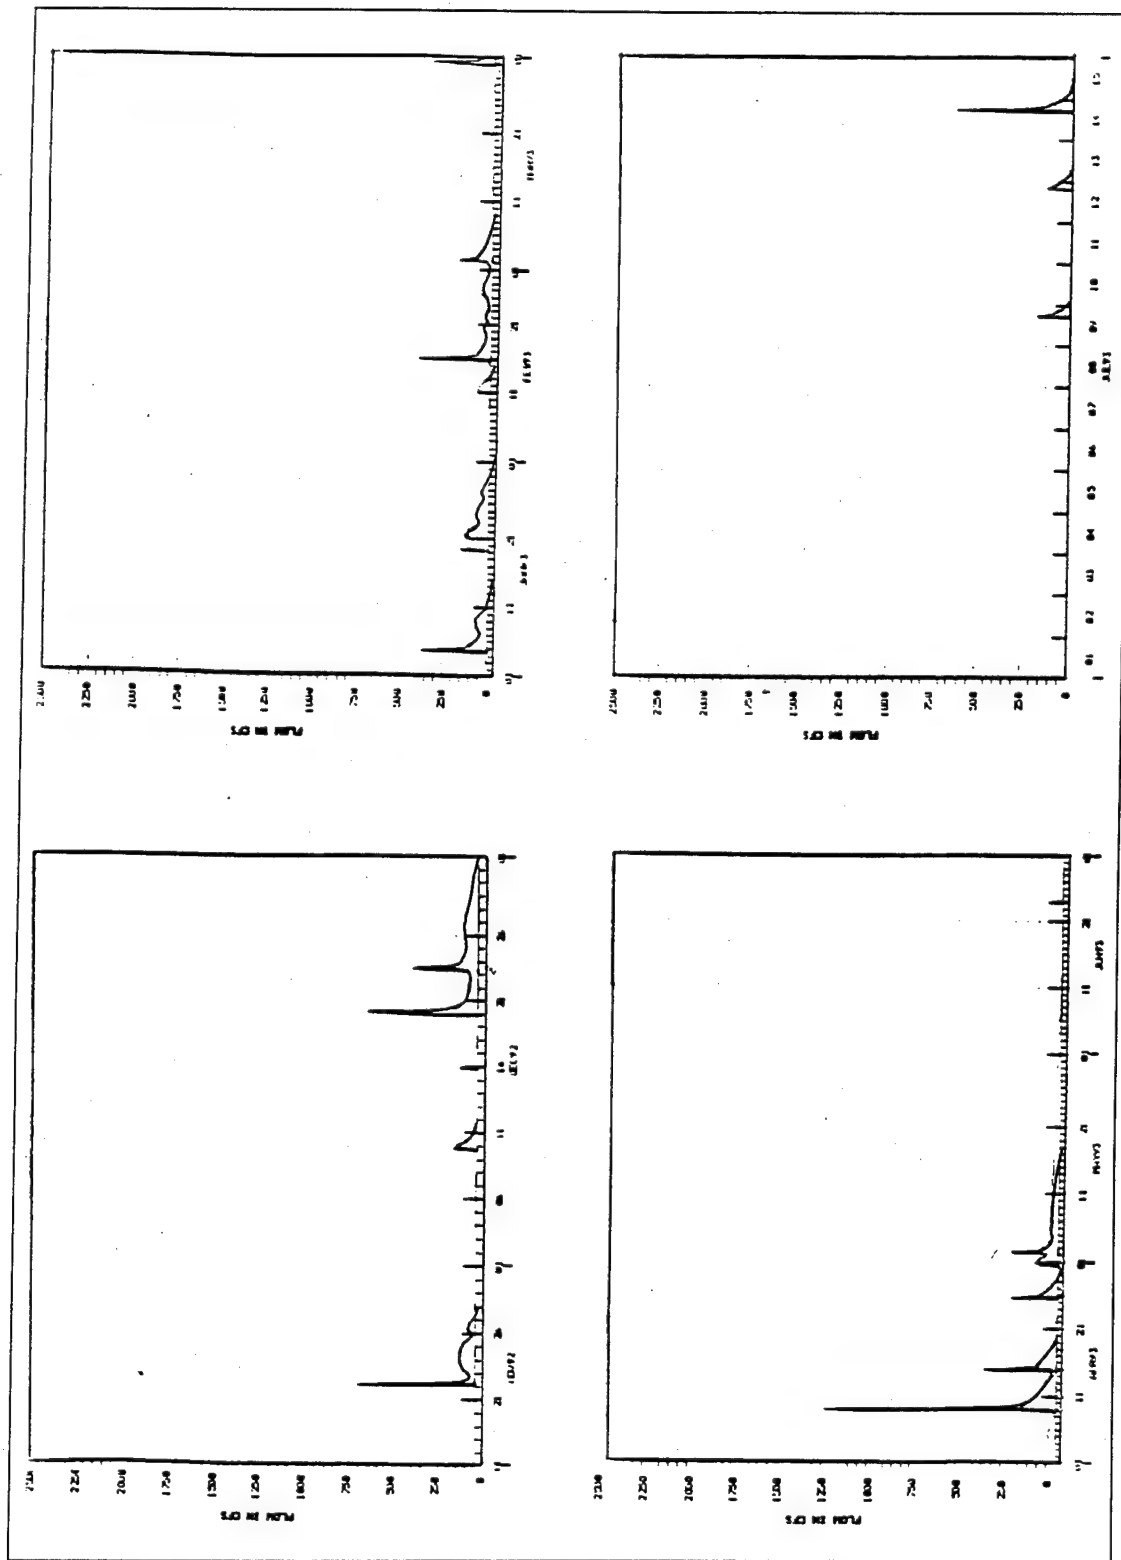
Figure 122. Discharge hydrographs, Hotophia Creek (November 1992-July 1993)

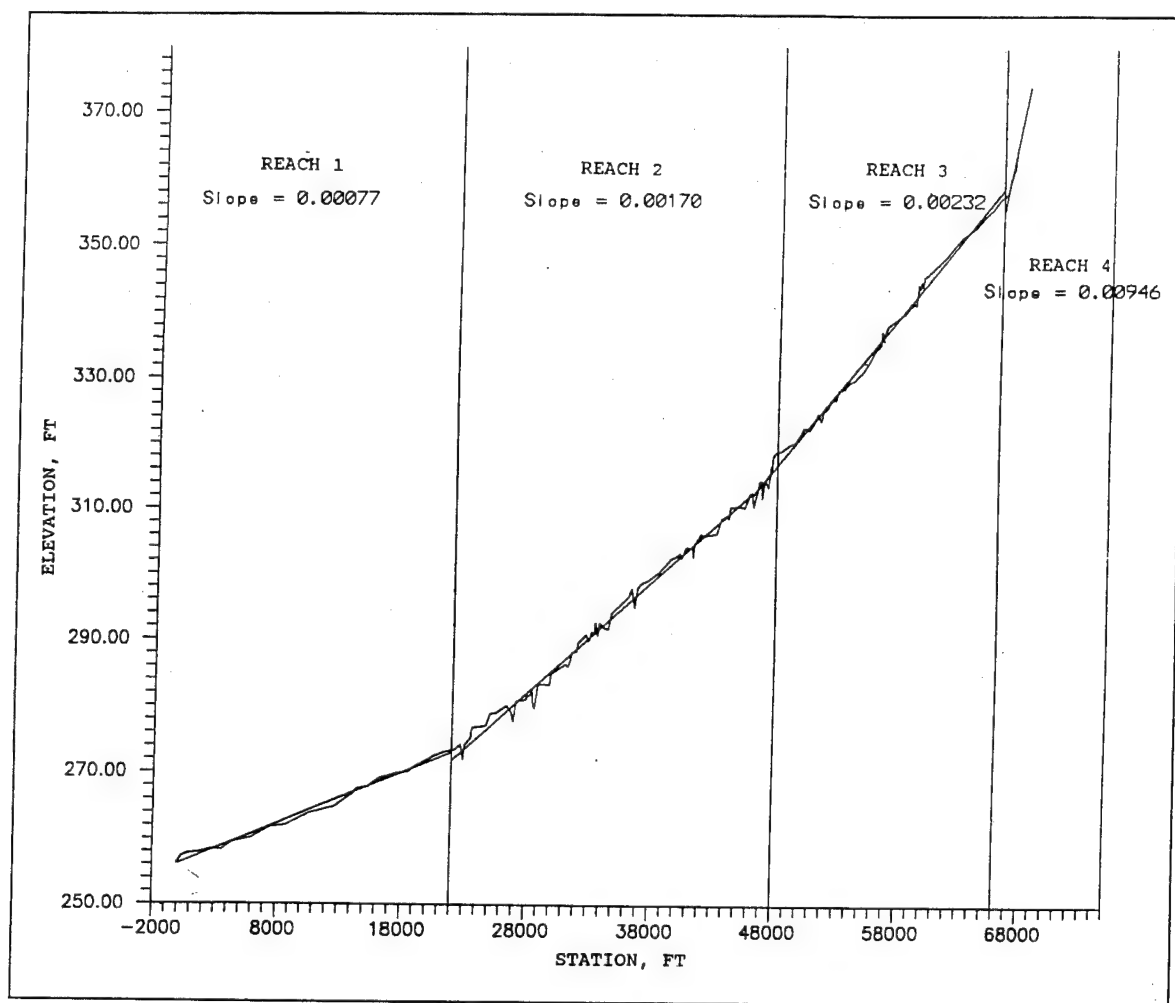
Figure 124. Average thalweg slopes by reach

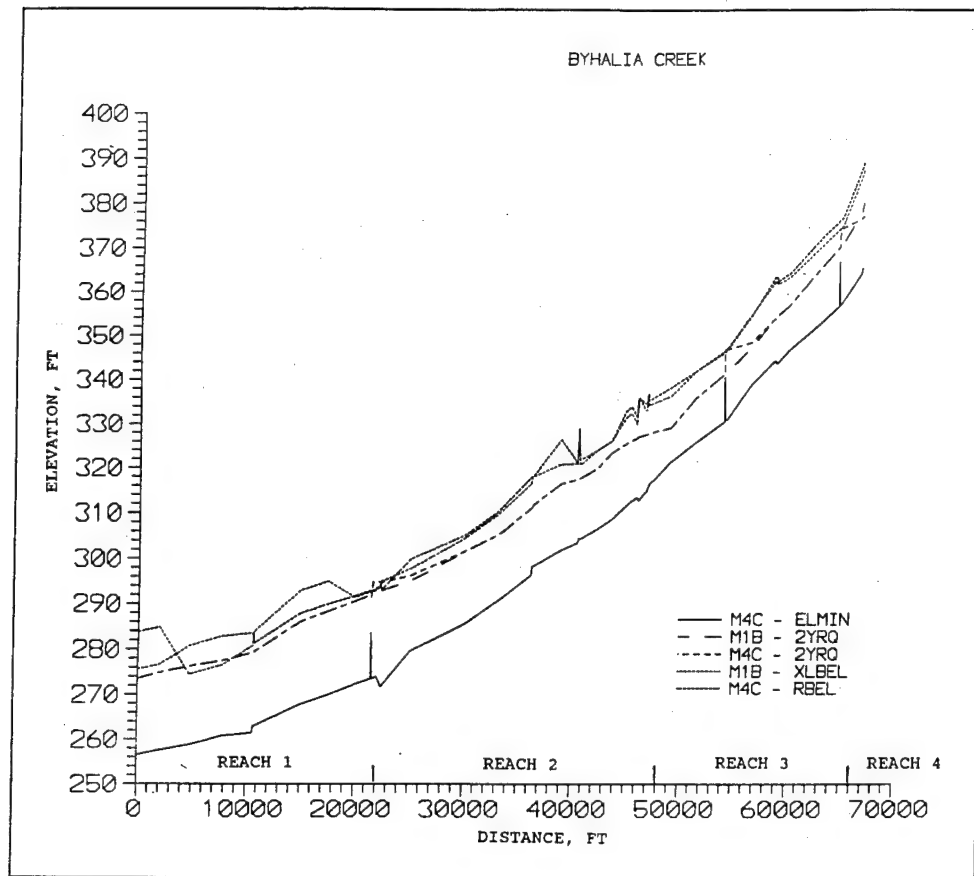
Figure 125. Water surface profile, bed and bank elevation plots

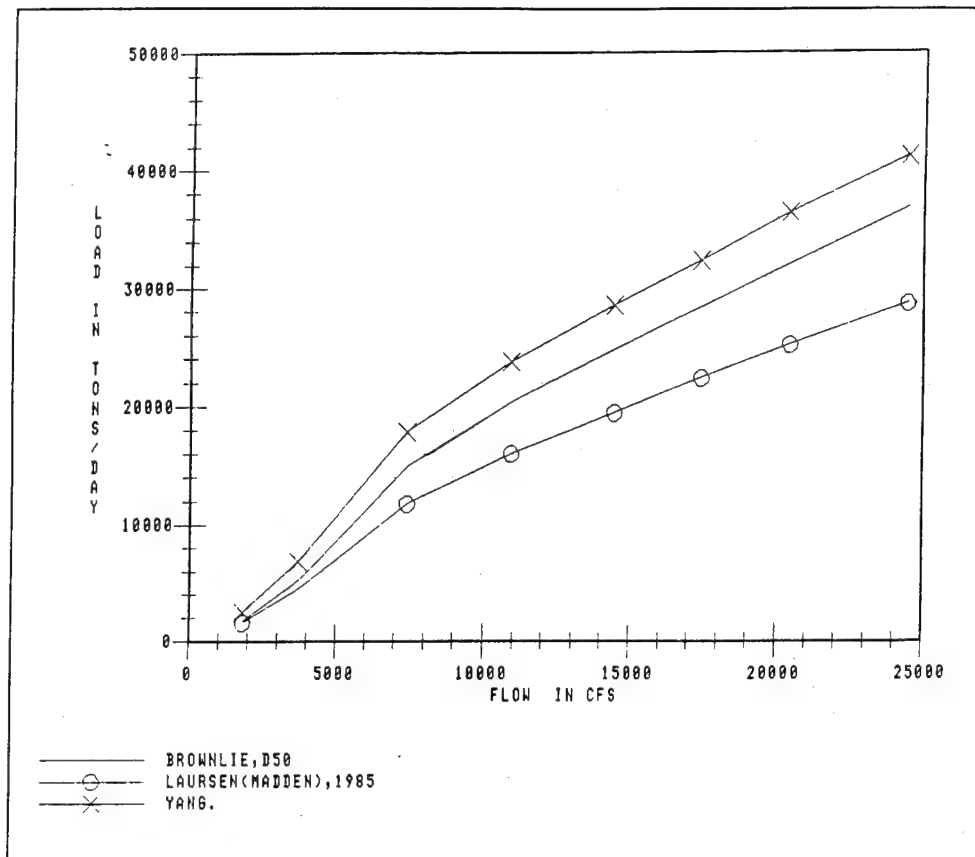
Figure 126. Transport function results

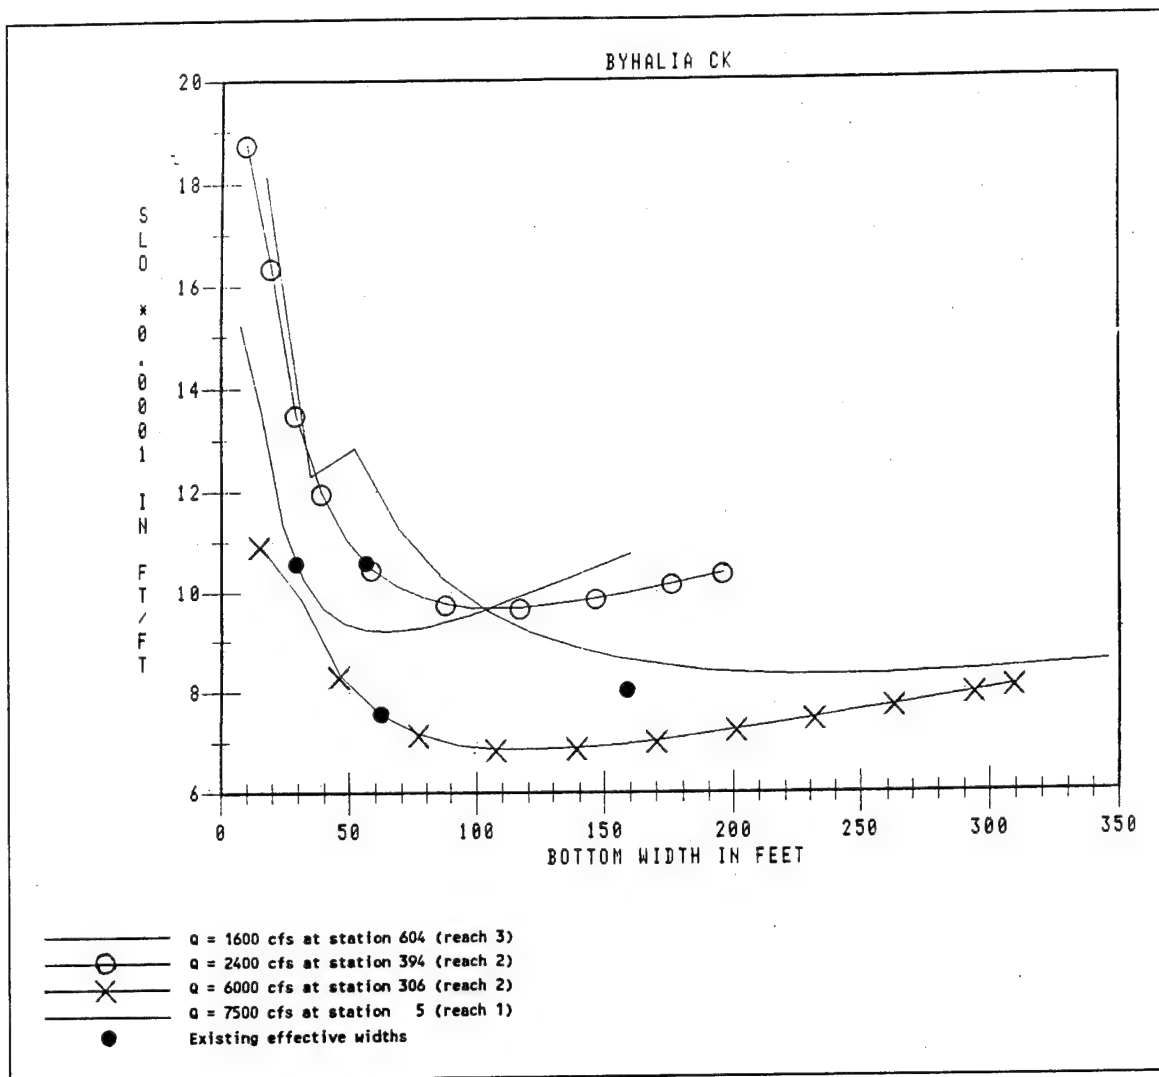
Figure 128. Stable channel calculations by reach

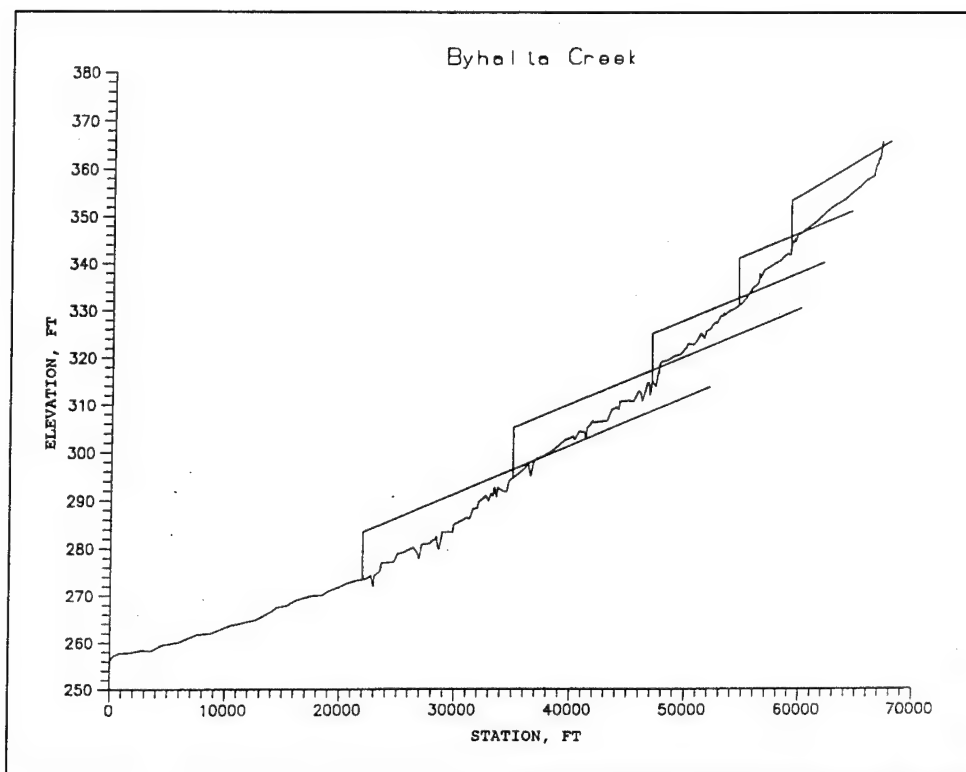
Figure 129. Grade control structure spacing

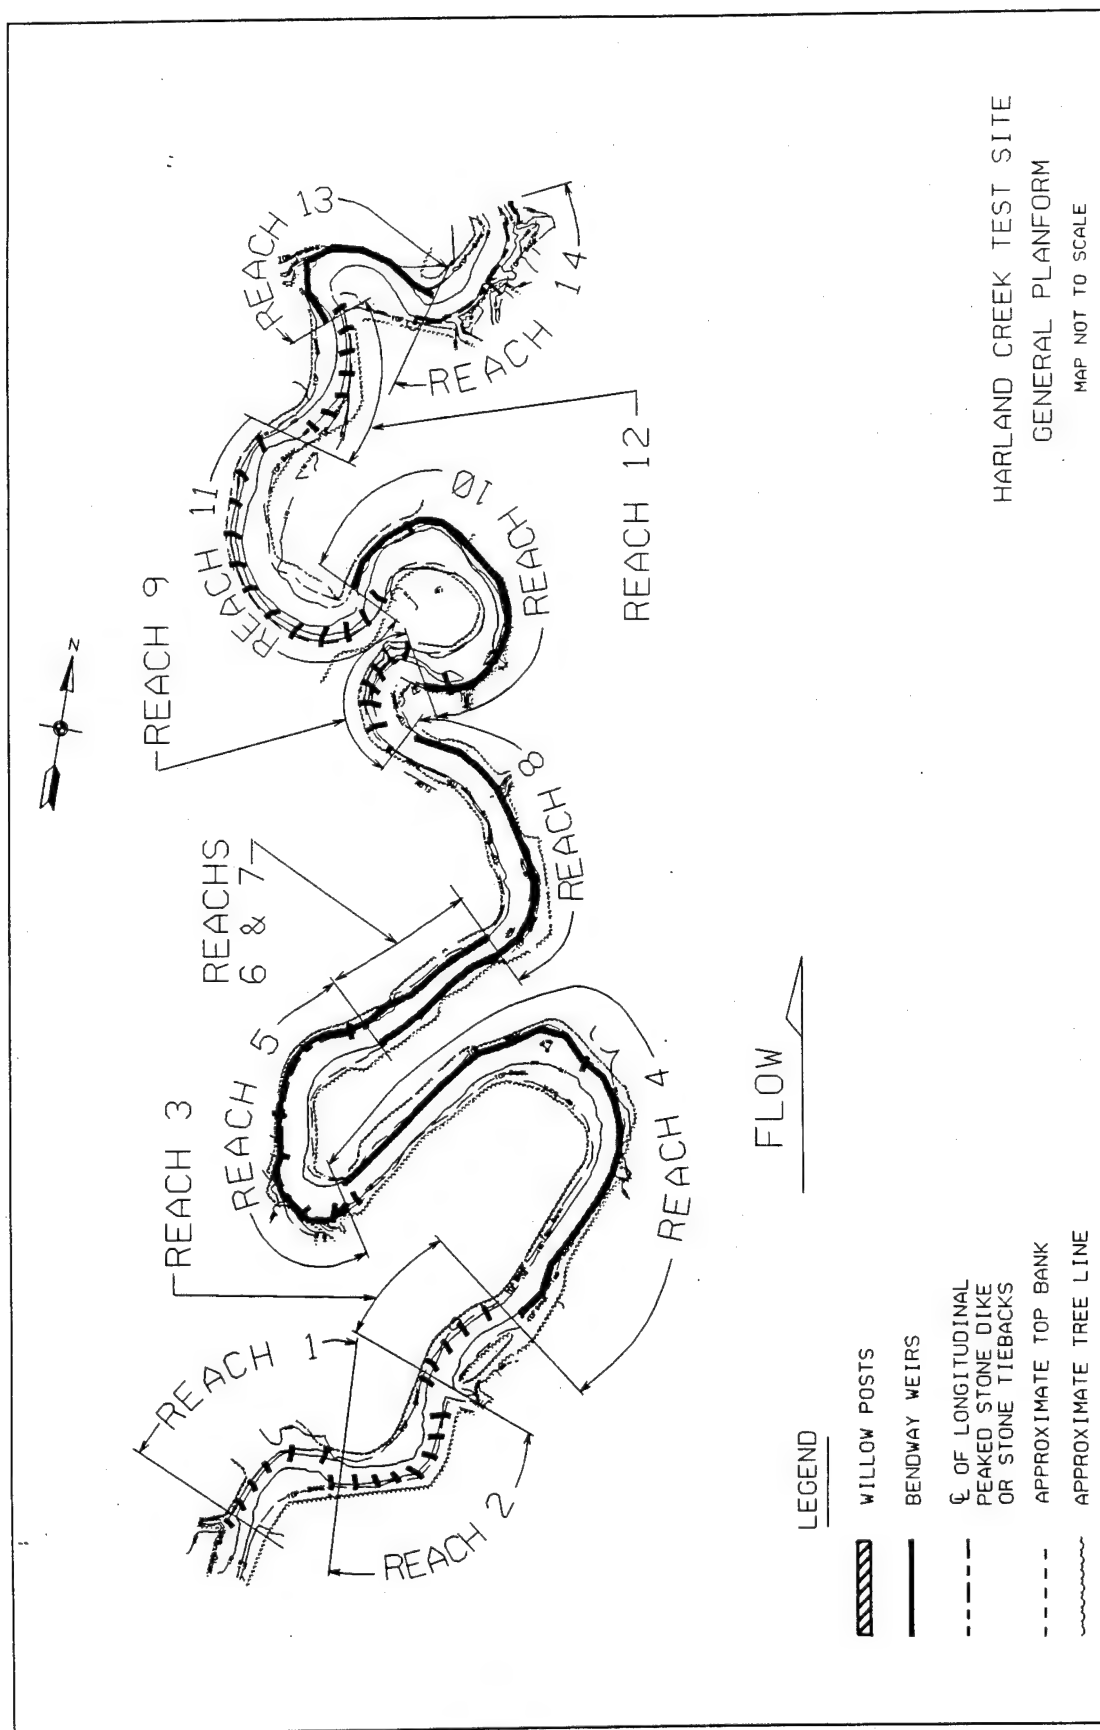
Figure 130. Harland Creek test site

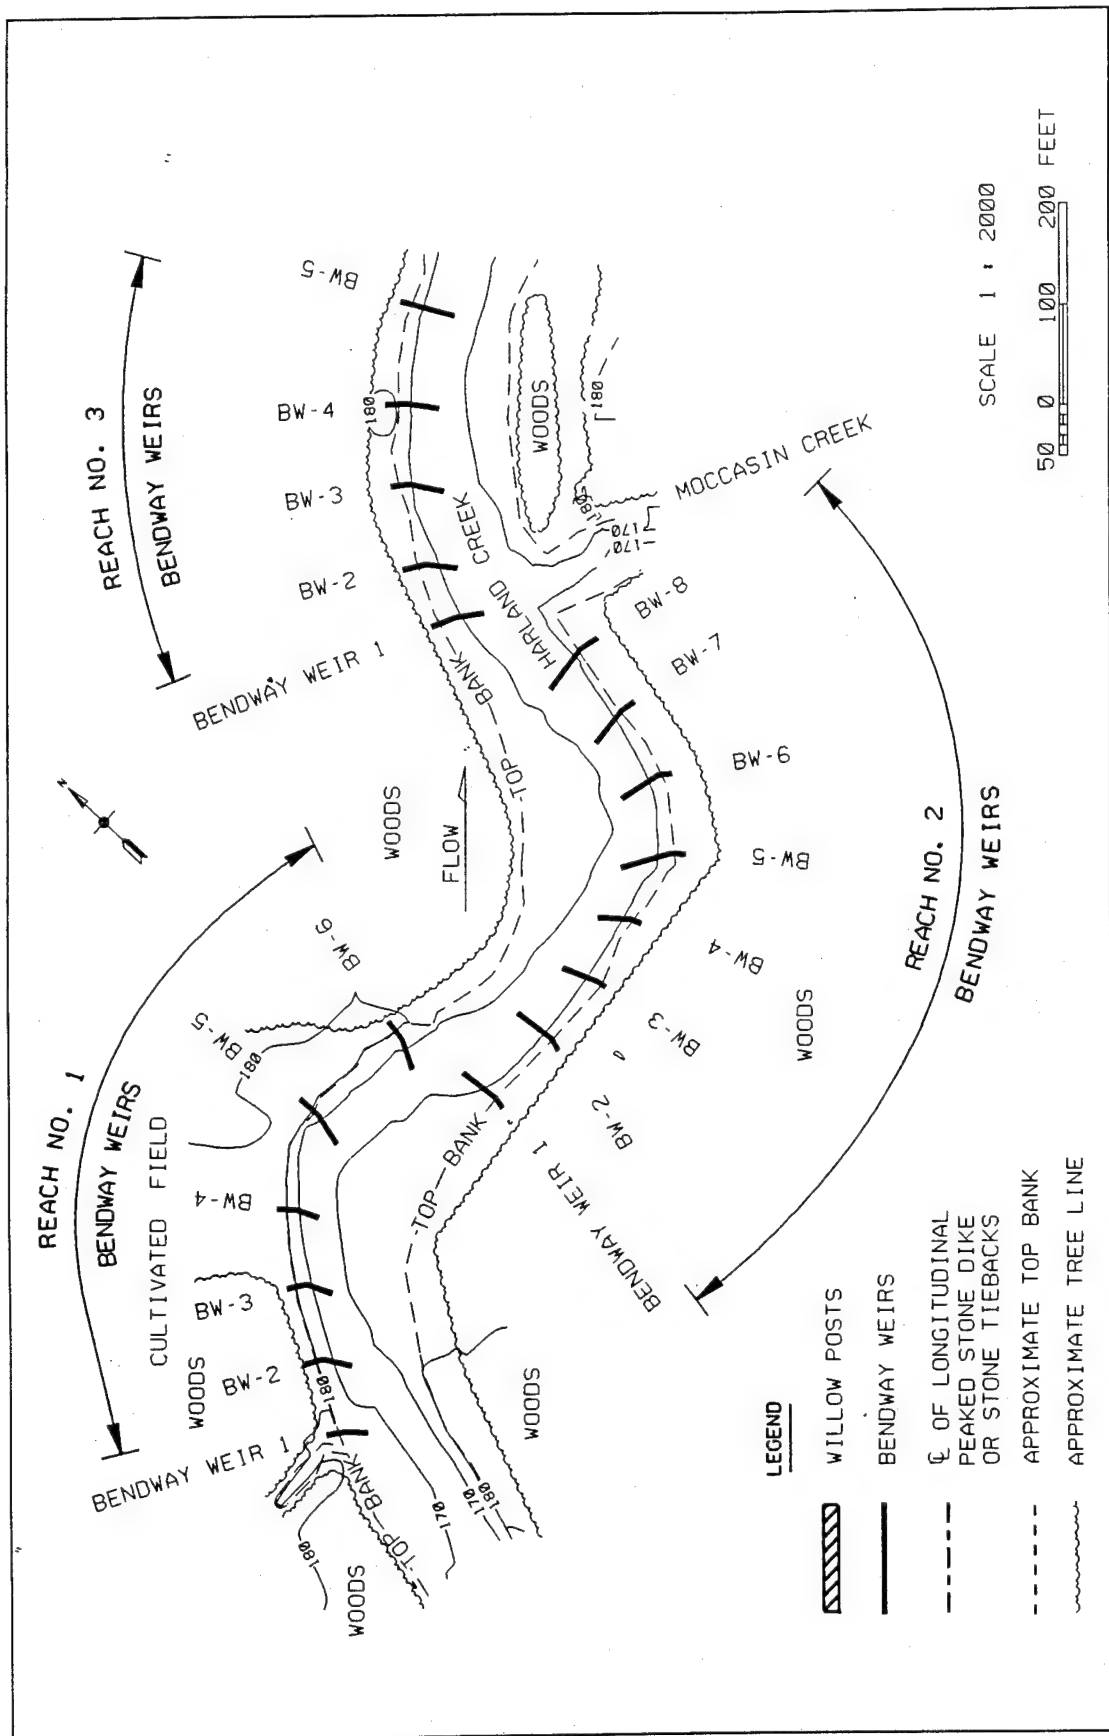
Figure 131. Harland Creek test site, reaches 1, 2, and 3
